URSZULA PASZEK

Road and Bridge Research Institute, Warsaw, Poland

DOI: 10.15199/40.2024.12.2

Selected corrosion problems of hydrotechnical structures

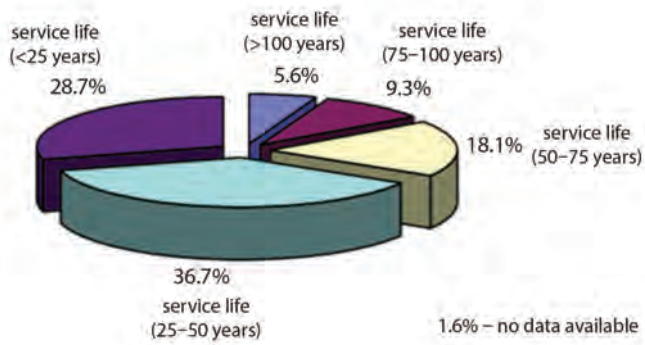
Fig. 1. Hydrotechnical structures classes I, III, IV and unclassified structures, permanently damming water – as of 31.12.2009, the actual service of the structure life was given

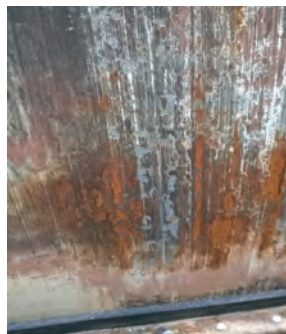
areas of unevenness, there was damage due to friction/wearing of successive layers, local corrosion and pitting corrosion (Photo 1);

Photo 1. Unevenness and damage of coatings and pitting corrosion

1. Correct coatings were used to protect the structure, as determined by infrared spectroscopy.
2. Damage to the coatings was observed (partial loss of all layers), up to the complete disappearance of all layers and the occurrence of corrosion processes and pitting. Greater destruction was observed on the upper water side.

It was recommended that the coatings should be completely removed, the surface be cleaned to Sa 2.5, and the protection be reapplied.

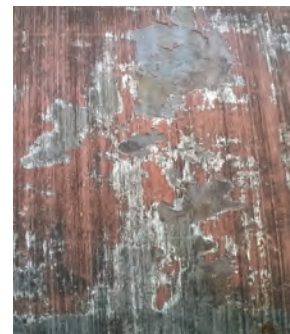
- local detachment of coatings from the pitting levelling compound (Photo 2);
- leaky connection of the seal with the wall surface allowing the accumulation of stones (Photos 3, 4).

Photo 2. Local detachment of coatings

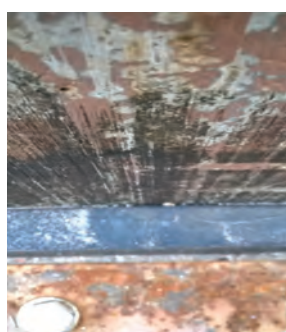
Photo 3. Leaky connection of the seal with the wall

4. Poor adhesion of the lower seal was found, resulting in dirt falling behind it. Damage to the coatings indicates mechanical damage, rather than leaching of the coatings, which was most likely caused by the impact of stones and other solid elements present in the water. The genesis of the damage is as follows: the formation of minor damage, followed by continuous and systematic waterlogging by flowing water and expansion of the damage, which was facilitated by the weakened adhesion of coatings in places.

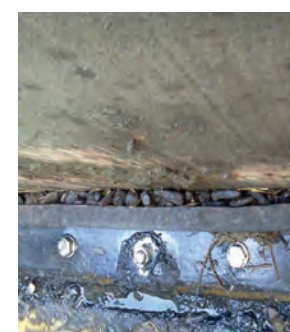
Photo 4. A crevice filled with stones

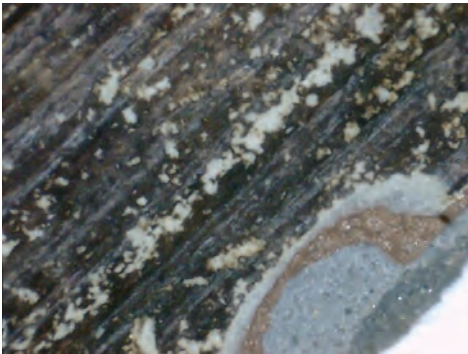
3. Along the vertical axis of the structure, unevenness of the coatings (referred to as “streaks”) was observed, and coating damage is similarly arranged, with the largest occurring at the bottom of the wall and the smallest at the top of the wall, which explains the different water flows in the top and bottom layers.

Photo 8. Damages and unevenness of coatings (from the top) in the vertical axis of the paintings – photo taken with a metallographic microscope

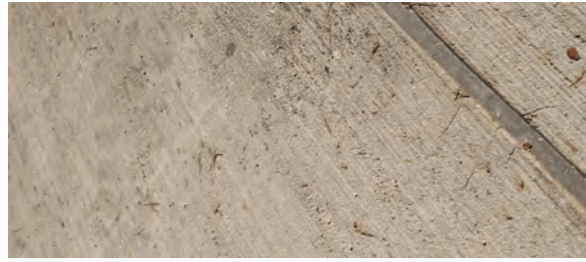
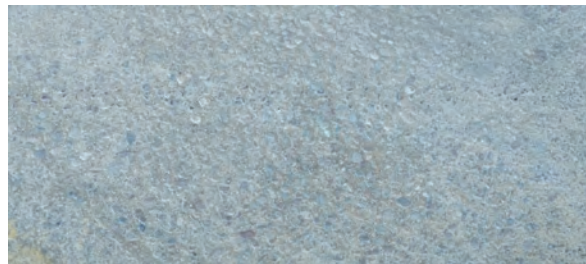
Photo 9. Effects of marine environment on elements of reinforced concrete hydrotechnical structures operating in a marine environment: a) exposure of diffuse reinforcement, b) exposure of the aggregate structure

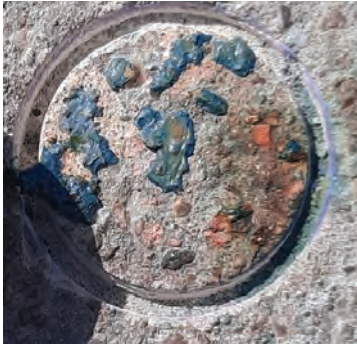
- Pull-off strength test – the test was performed in accordance with PN-EN 1542 [25] using a DYNA Z-8 device. 50 mm diameter punches were used for testing. Epoxy glue was used for bonding. Six measurements were made. An example of the type of punch breaking off from the substrate is shown in Photo 10.
- Determination of the degree of carbonation of concrete – the determination was carried out on the pull-off sites. Rainbow test was used for the test, which, after reacting with the concrete substrate, stains to a specific colour assigned to the corresponding pH value. An example of the determination with the Rainbow test scale is shown in Photo 11, where it is indicated that at a depth of 5 mm the pH of the concrete is acidic.

Photo 10. View of a sample detachment during work on a concrete wharf

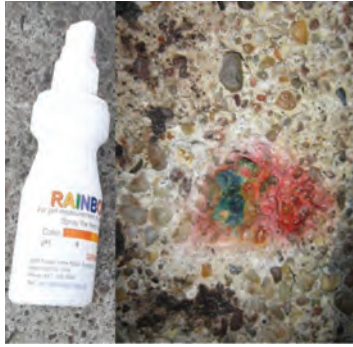
Photo 11. One of the test locations used to determine the concrete reaction at the measurement site

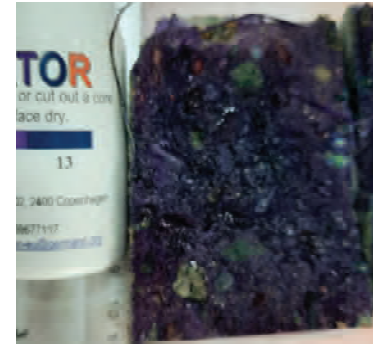
Photo 12. Cross-sectional view of the sample
Fot. 12. Przekrój poprzeczny próbki

Examination of the cross-section indicated that the concrete was not damaged in depth, confirming that the nature of the impact was only superficial for the time being and did not pose a risk to the bearing capacity of the structure.
